Article 7: Town Hall Restoration

Saugus Town Hall

Exterior Conditions and Treatment Recommendations

June 2, 2017

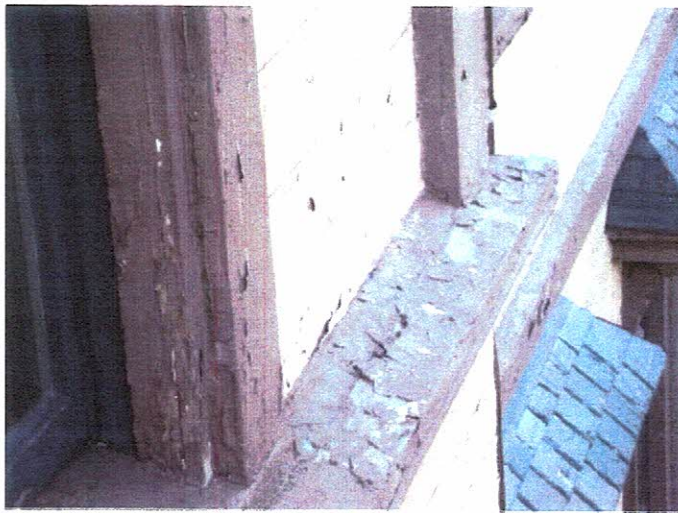
The condition of the paint on the building is generally poor, primarily due to improperly prepared substrate prior to repainting. Multiple layers of paint have become very thick in some areas, causing it to delaminate at the wood surface (Figures 2-4). It is also possible that incompatible types of paint were used, in which case the paint would not adhere well to the previous layer.

Figure 2: North elevation, thick layers of paint delaminating from the surface.

- Remove 100% of paint to bare substrate from the exterior wood elements
- Repaint using an appropriate 3-coat paint system

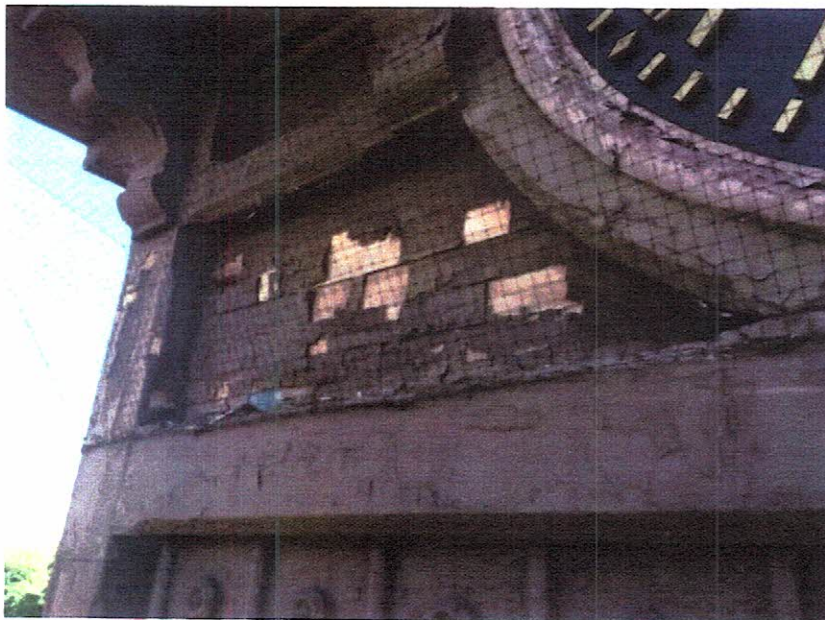
Figure 3: West elevation, clock tower. Thick paint loss exposing bare wood substrate.

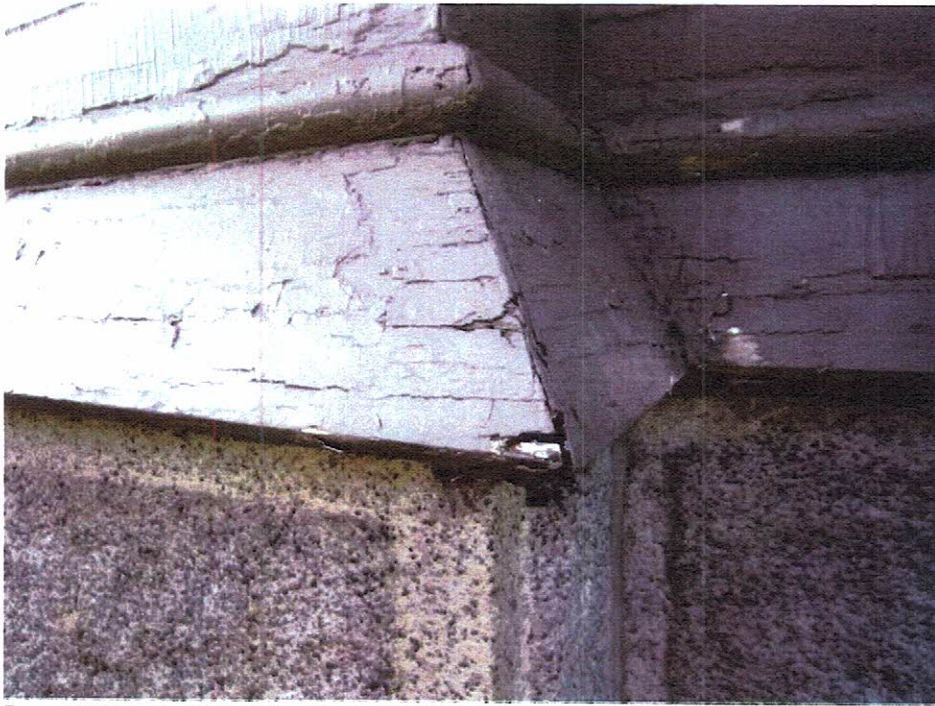
Figure 4: North elevation, typical condition of banding above granite foundation.

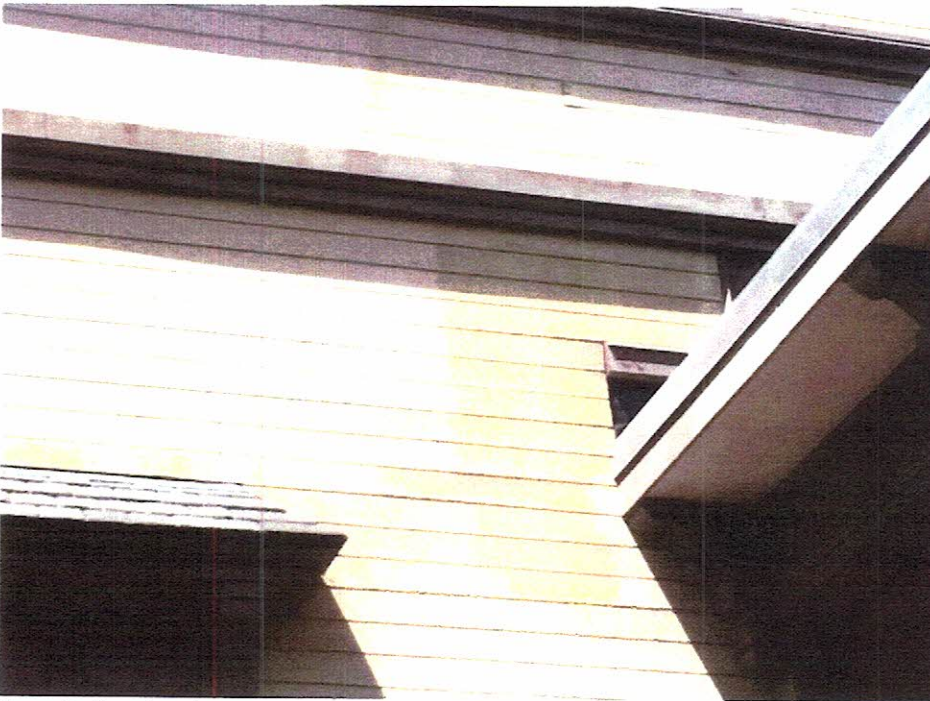
Paint adhesion is performing fairly well on the replacement wood, however there is some unusual discoloration occurring on the west elevation. In addition, the paint on the east elevation appears much like an opaque stain rather than a traditional paint (Figure 5).

Figure 5: East elevation, apparent opaque staining and discoloration of some areas.

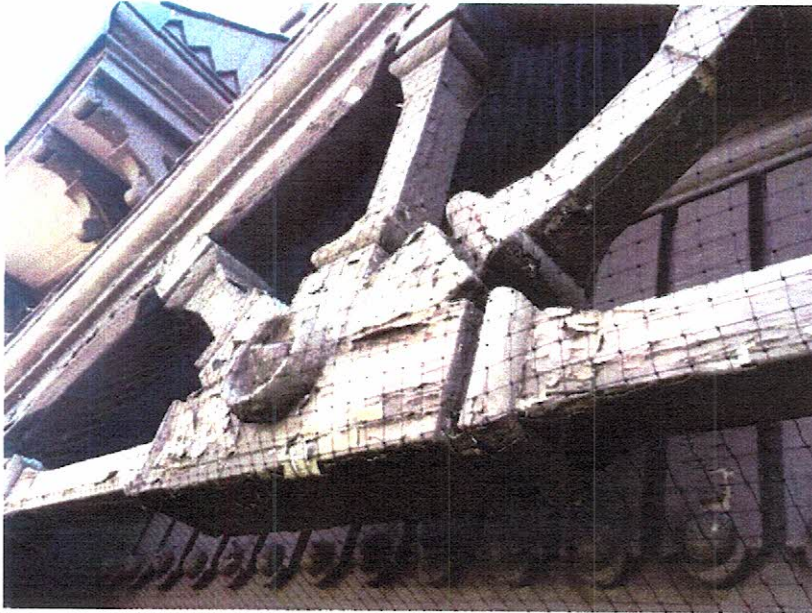
In many cases, the peeling paint is so heavy and unsightly, it gives the appearance that deterioration of the wood substrate is in far worse condition than it actually is (Figure 6). The extent of wood deterioration is discussed below.

Figure 6: West elevation tower, decorative element paint failure, substrate in good condition.

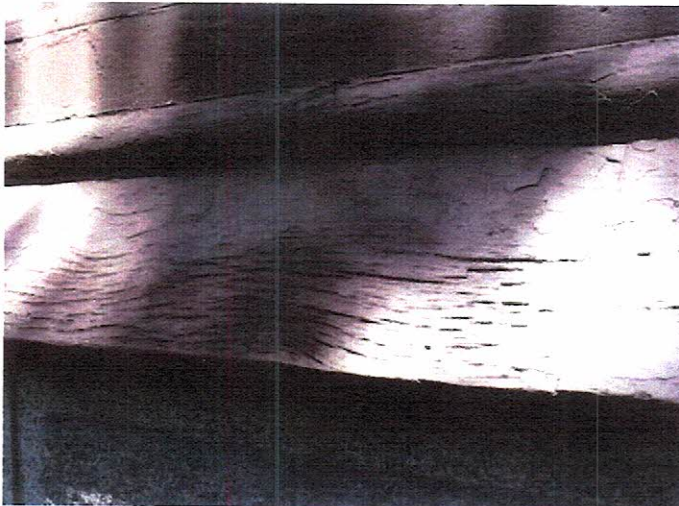
Paint failure and loss are the main contributing factors to varying levels of wood deterioration on the building. Bare wood exposed to sun, rain and wind will weather and denigrate rather quickly. Weathering and checking of the wood is most common condition on the Town Hall's exterior. This is most often found at the projecting banding at the watertable and the banding just below the second floor windows as well as window sills. The banding acts as a "shelf" for water shedding from above (Figure 7).

Figure 7: Typical weathering and checking of wood on projecting surfaces.

- Consolidate weathered and checked areas of wood
- Reinstall loose and displaced units of wood
- Replace portions of deteriorated wood units with new wood dutchman
- Replace deteriorated units of wood to match existing

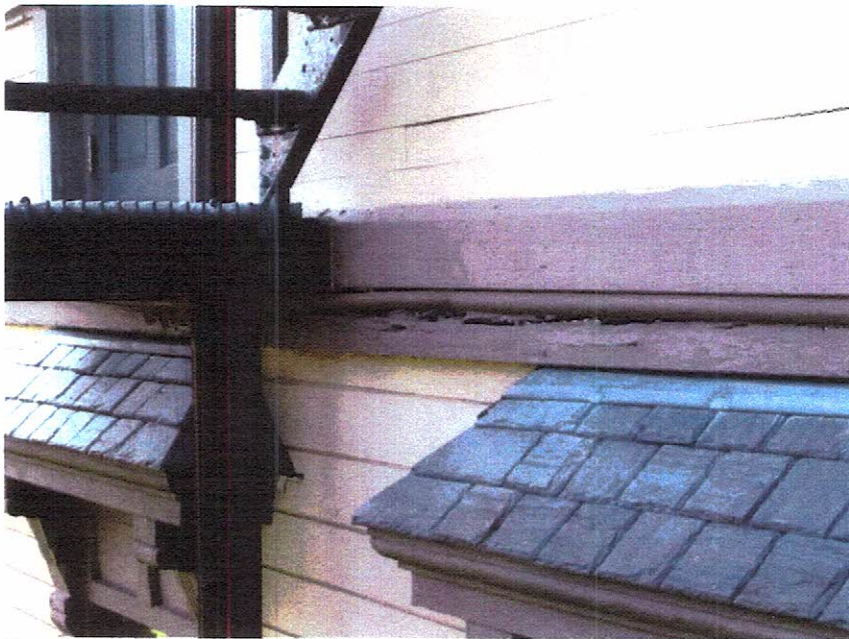
There are also locations where portions of wood units have deteriorated or rotted to the point where they cannot be repaired. In most cases, the entire unit will not need replacement, only the damaged portion, which can be replaced with a wood dutchman. There are a limited number of areas requiring a combination of consolidation, dutchman, and complete replacement (Figures 8,9).

Figure 8: North elevation, wood element requiring partial replacement (dutchman).

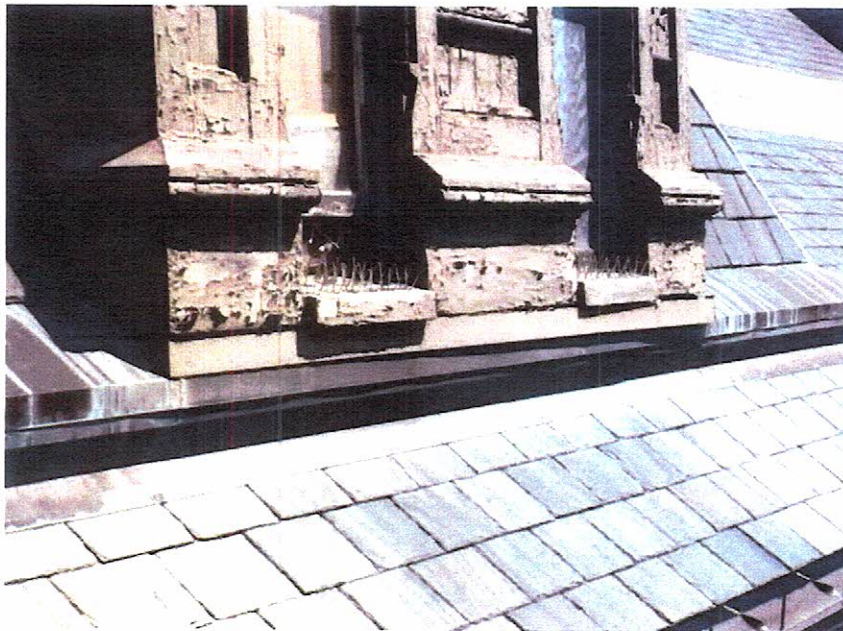
Figure 9: South elevation. Dormer in need of consolidation, dutchman, and reattachment of loose units.

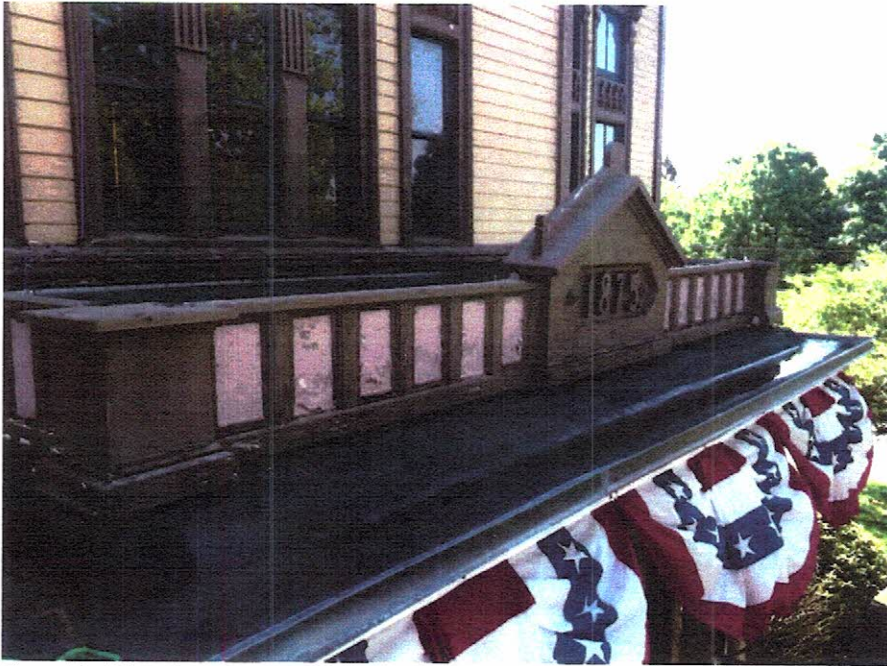
The balustrade above the west entry portico is in very poor condition (Figure 10). It is rotted in some areas completely through the depth of wood. Poor drainage on the roof and lack of drying out are likely responsible (Figures 11,12). It is unclear how much of the original material can be salvaged, however the central block that reads "1895" appears to be restorable (Figure 13).

Figure 10: West elevation, paneled balustrade above main entry portico.

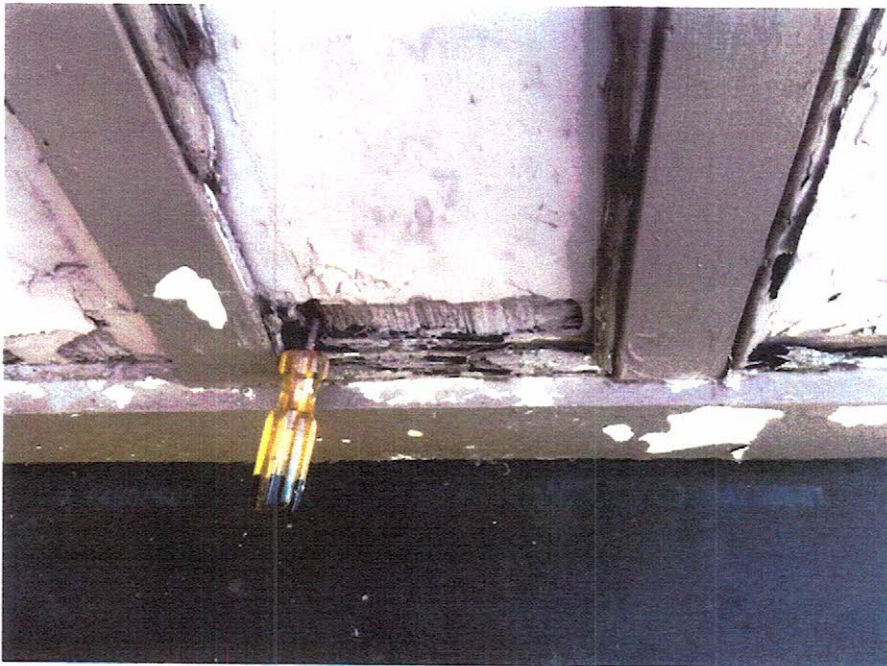
Figure 11: Panel on north side of balustrade completely rotted through.

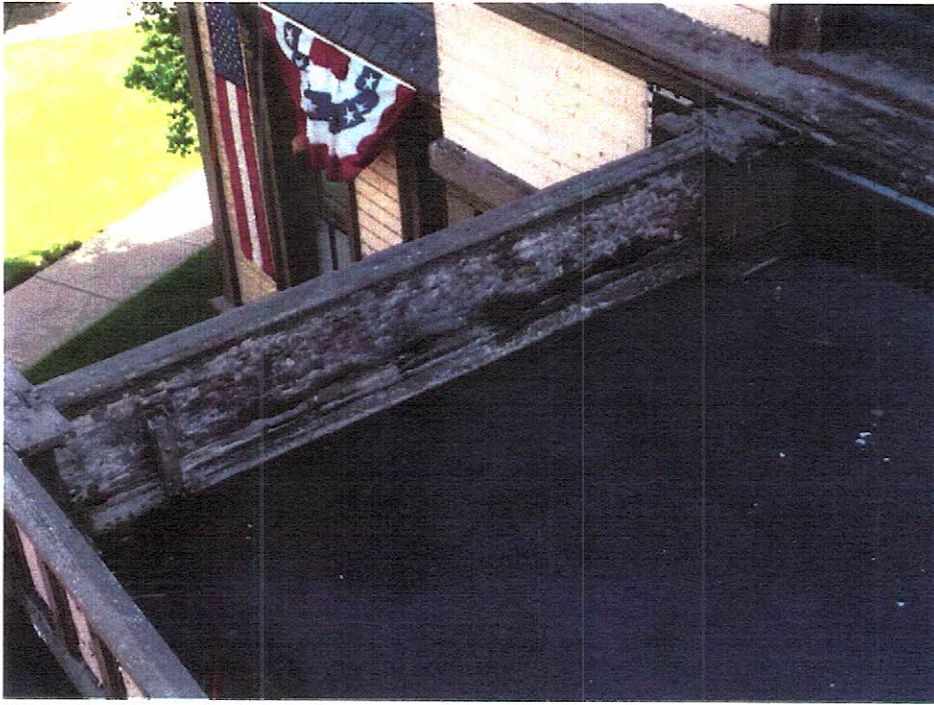
Figure 12: Entry portico balustrade, poor condition of interior wall.

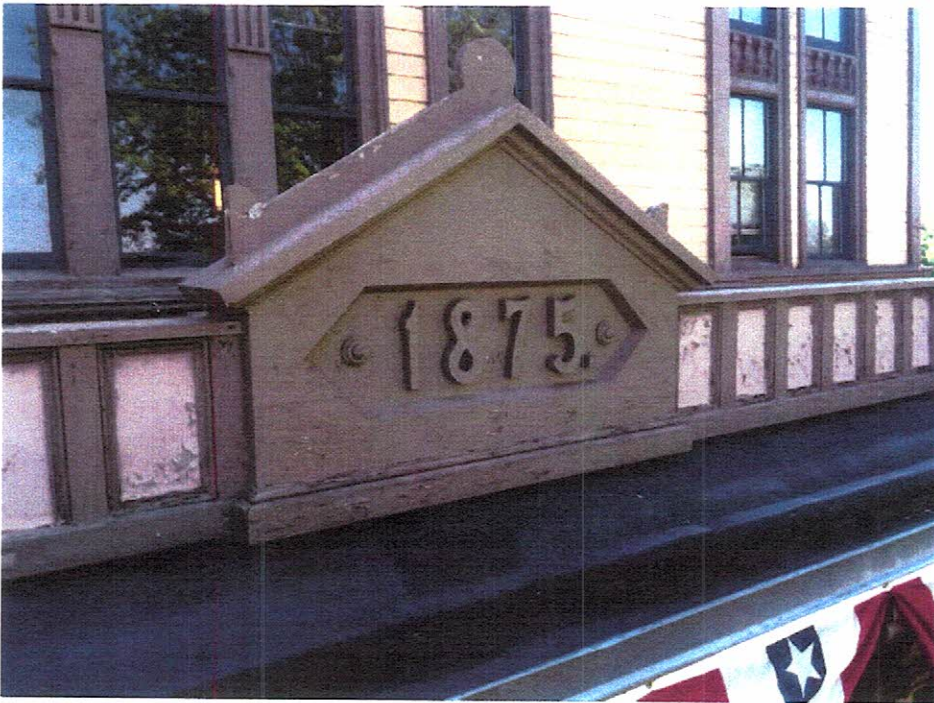
Figure 13: Balustrade central panel in restorable condition.

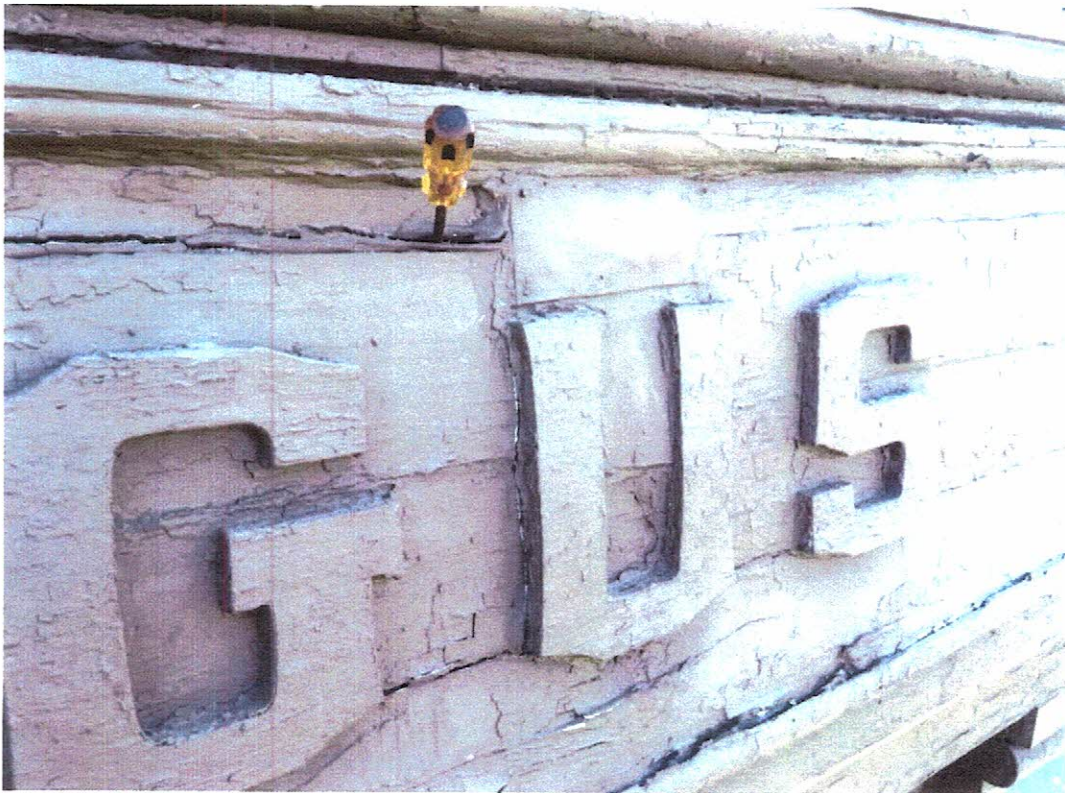
The clock tower on the east end was only accessible by aerial lift up to the clock face. From the ground the tower appears in fair to poor condition, however closer inspection of revealed little substrate damage, but with heavily peeling paint. The cupola above the clock tower was not very visible, however it appeared in relatively good condition, likely in need of repairs in some locations. The "Saugus" panel is in poor condition (Figure 14). Boards and letters are loose, and most of the wood is very soft. As it is an important part of original material on the building, it should be fully restored if possible.

Figure 14: "Saugus" panel on the clock tower in very poor condition.

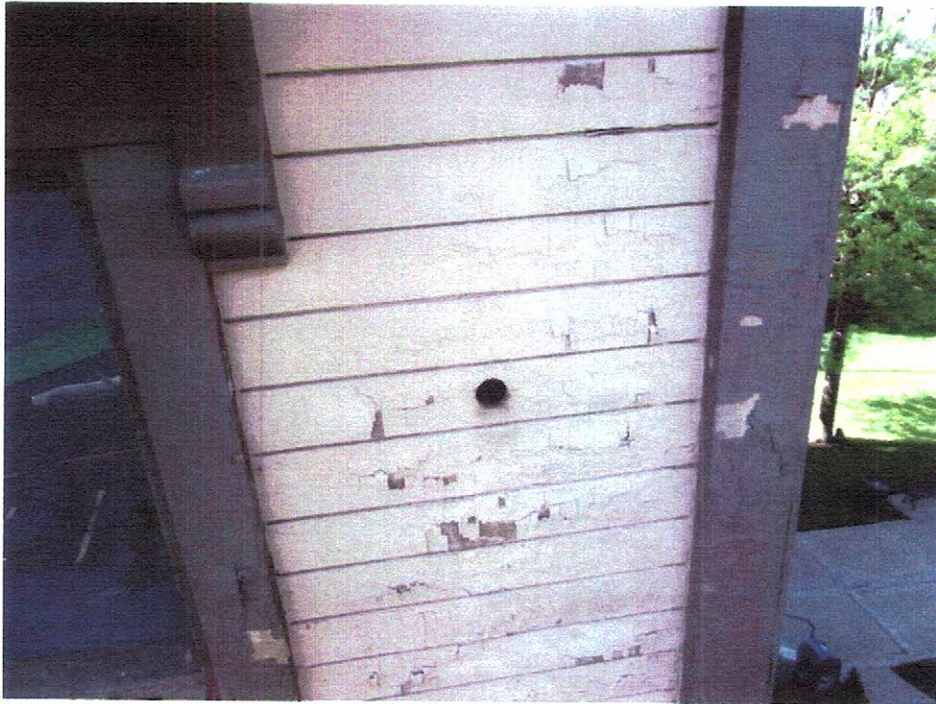
There are multiple areas on the north, south, and west elevations where insulation was blown in and plugged with a piece of wood. There are several plug locations that are allowing water in as they are not properly sealed, and in a number of areas the plugs are missing and birds are nesting in the wall (Figure 15).

Figure 15: North elevation, missing plug for blown-in insulation.

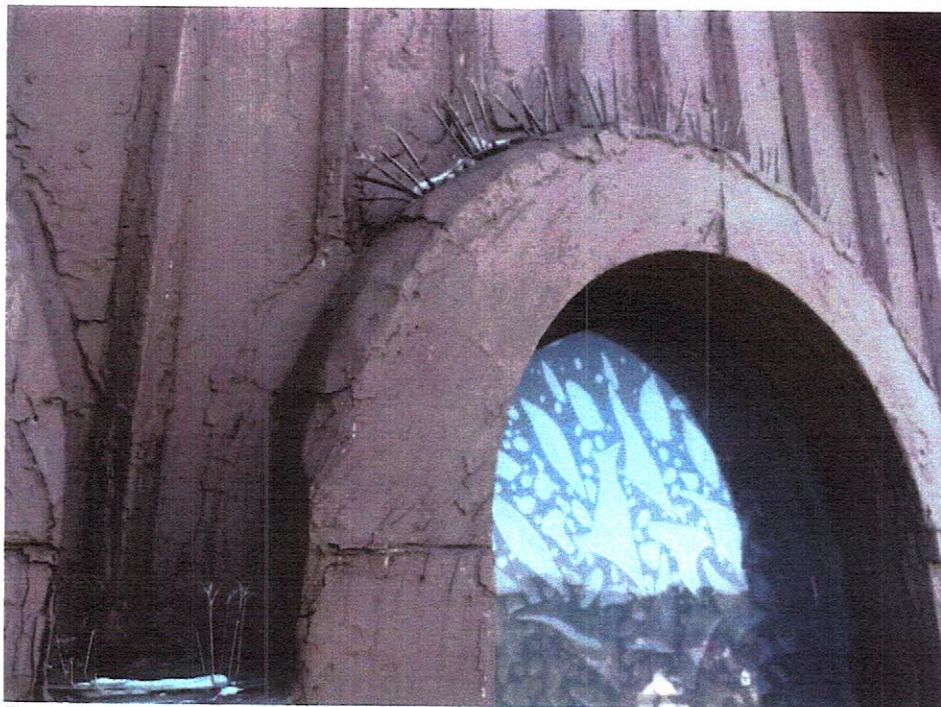
Bird netting and spikes are installed around the building. In some locations its installation has been detrimental to the wood substrate, not well adhered, and is visually unpleasing.

Figure 16: Typical application of bird spikes.

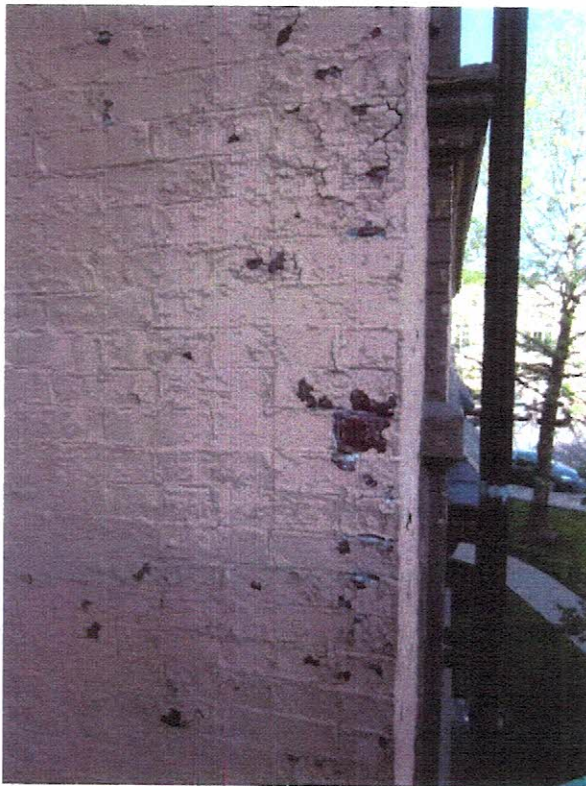
The brick chimney located on the north elevation has also been painted multiple times. Paint is peeling heavily on this masonry as well. It was noted in some of the exposed brick there is notable mortar loss. Inevitably a non-breathable paint was applied, trapping moisture in the brick and mortar (Figure 17). The trapped moisture deteriorates the masonry by freeze thaw cycling.

Figure 17: North elevation chimney. Note mortar loss in exposed brick.

- Remove 100% of paint from masonry using chemical strippers
- Assess condition of brick and mortar
- Perform necessary masonry repairs
- Determine if the chimney had historically been painted. Consider not repainting if possible
- If repainting is implemented, use an appropriate mineral silicate masonry paint system

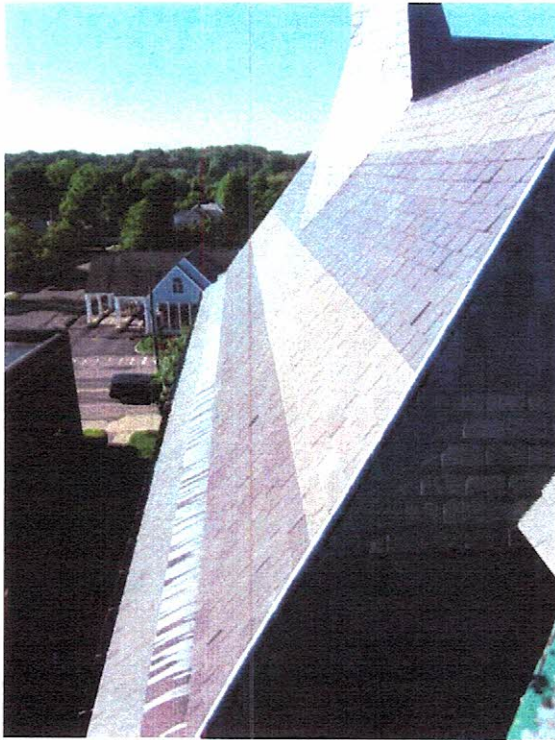
The Town Hall's roof system is of complex design. There are multiple gables roofs, dormers, valleys and hipped roofs that make up the slate portion of the roof. The slate is in very good condition, with only a few slipped and missing slate (Figures 18,19). The history of the roof is unclear; it does not appear that the slate was replaced during the 1998 work, however the existing slate may have been rehung as the flashings were replaced with new lead coated copper. The slate is not likely original, given its good condition, however it may have been replaced many decades ago. Flashings, gutters and downspouts are in good working condition.

Figure 18: East elevation roof in good condition.

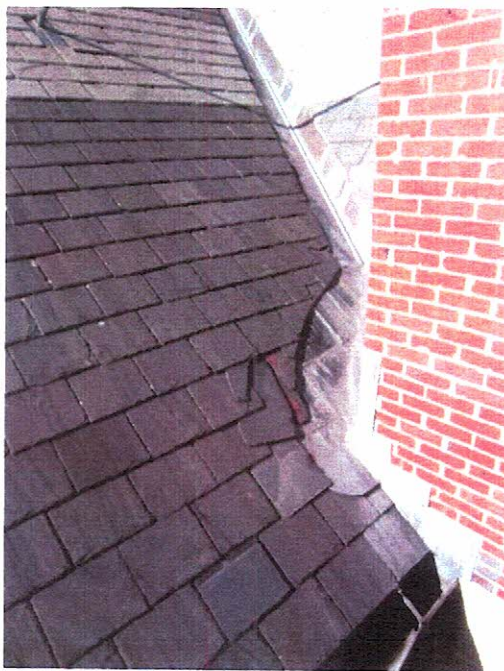
Figure 19: North elevation, slipped slate at chimney.
(Slate were checked, these are not in danger of falling)

- Rehang slipped slate with new copper nailing
- Replace missing slate
