Evaluation of Wastewater Pumping Stations- FINAL

Town of Saugus, Massachusetts

September 2014

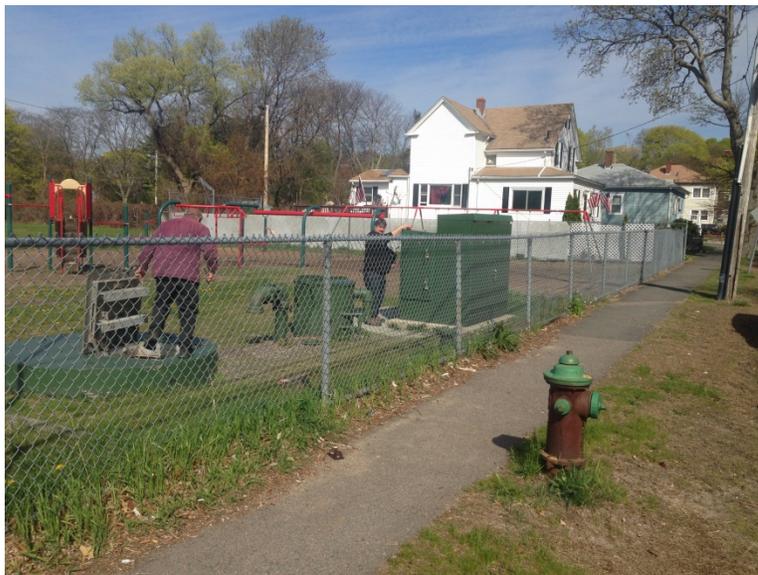
The Bristow Street PS is a below grade, 'dry-pit' type pump station. The station consists of an 8-foot diameter precast concrete vault structure with a 3-foot diameter steel access tube constructed of steel plate. The stations pump chamber is accessed via an aluminum ladder. It is estimated that the floor of the station is approximately 22-feet below grade.

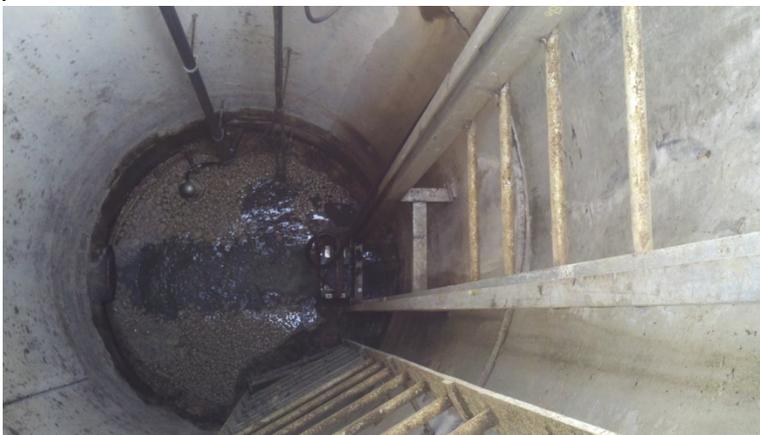
- The seal water (recycled wastewater) filters should be replaced.
- The suction and discharge pressure gauges should be replaced. The discharge gauge on Pump #2 is the only functioning gauge.

- Clean out debris from bypass gate valve box and verify that valve is operable.
- Consider adding lockable/tamper resistant gate box cover.
- Calibrate the magnetic flow meter.
- Add a motorized air intake at the can station.
- Replace the suction and discharge pressure gauges.
- Replace the sump pump.
- Replace the recycled wastewater seal filters on both pumps.

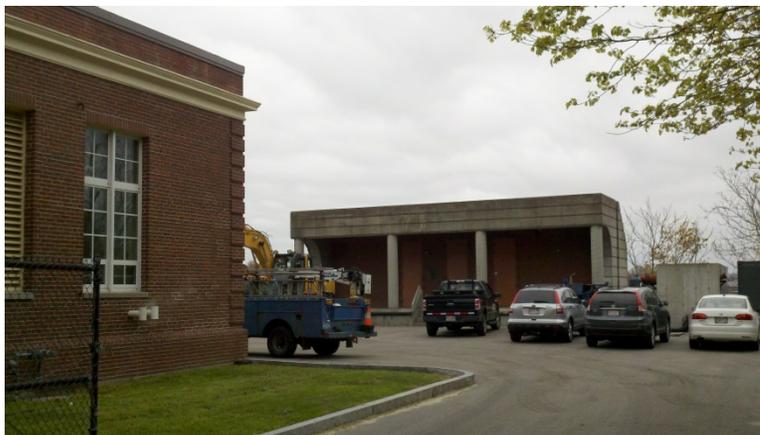
“The Lincoln Avenue Pumping Station consists of two structures, namely the old pumping station and the new pumping station. In the past, the old pumping station housed the entire pumping facility, plus equipment for the water department. It now houses the electrical controls, standby generator, and heating system for the new pumping facility. The new pumping station is an underground structure with a super structure for access, housing all wastewater handling facilities including the wet well, pumps and piping.”

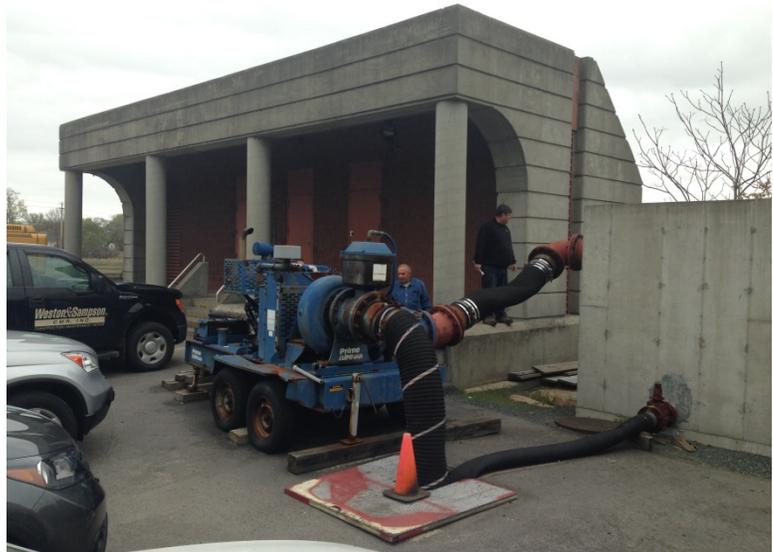
During our visit, a means for handling excessive flow events was observed at the Lincoln Avenue Pumping Station. A standby pump is situated in the driveway of the pumping station, which can be utilized to pump flows from the influent manhole structure to a coarse screen filter box for discharge to the Saugus River. Dry chlorine is added to the flow as a means of disinfecting the flow prior to discharge to the river.

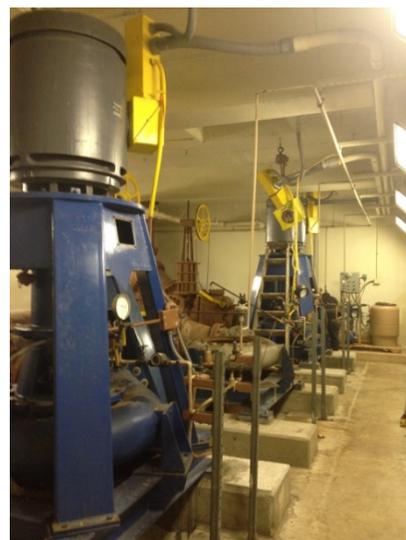
- Pump Room – Spare parts were observed. Spare

parts consisted of woods coupling flanges, wear ring, shaft sleeve and impeller/wear ring assembly.

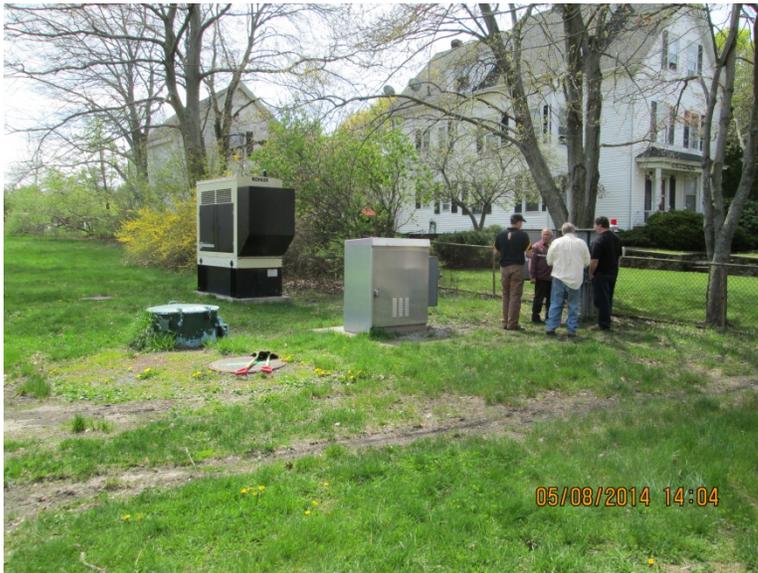
The existing wet well is constructed of pre-cast concrete manhole sections. The base of the wet well is comprised of 6-foot (inside diameter) sections. The operating range (pump on to pump off) for the pump station is 30-inches, or approximately 530 gallons. The base is topped with 4-foot diameter manhole sections and a 30-inch frame and cover for access.

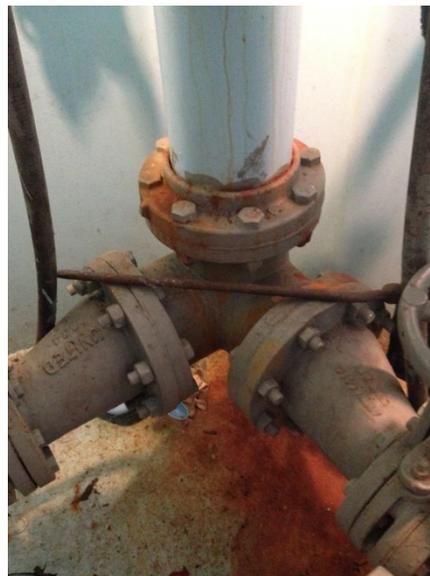
- The Town indicates that a significant amount of rags are found in the collection system, which leads to pump clogging issues.
- Pumps and motors are in good condition (replaced in 2006).
- Pump vibration testing was performed on both pumps by L.P. Larson, Corp. on May 16, 2014. Results of this testing conclude that both pumps tested within the acceptable range based on predetermined alarm levels.
- The dehumidifier was non-functional.
- The sump pump should be replaced.
- The entire station needs to be re-painted (including piping/pumps).
- No plumbing hose station is present.
- The exhaust fan was non-functional (i.e. jammed up).
- Rust was observed on the mechanical piping.

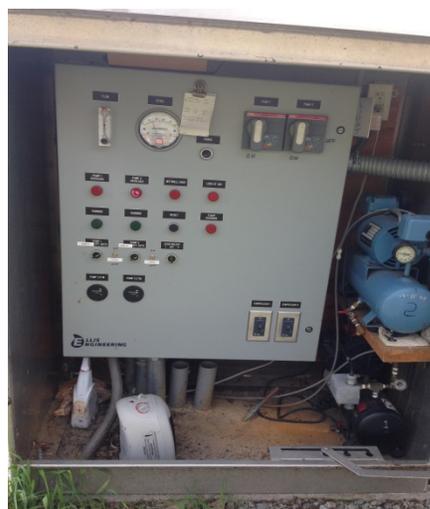
- The power supply does not have an electronic surge protection (TVSS) device protector.
- The primary controls are bubblers with two simplex air compressors. There are secondary controls.
- The outdoor electrical enclosure does not have a cooling exhaust fan and filtered air intake.
- The electrical power equipment does not have engraved plastic nameplates and NEC electrical shock hazardous warning labels.
- The below grade pump station does not have emergency (battery operated) lighting.
- The SPS alarms are limited and not TR # 16 compliant.
- The engine/generator does not have a remote "Emergency Power Off" control station.

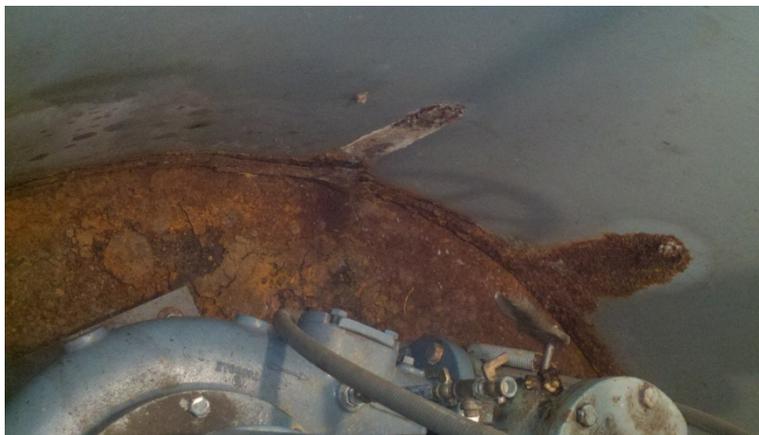
- There are holes completely through portions of the can structure to the adjacent soil.
- The floor of the station is completely delaminated and has pulled away from the seam at the walls.
- The force main sleeve at the ceiling is cracked.
- Steel thickness readings by Baker Testing were not completed on the floor due to the existing condition. See photos in test report. Though testing indicates that the access tube and base walls have somewhere between 0.219 and 0.257-inches of steel remaining (likely 0.25 inches thick to start), there are many locations where 0-inches of steel remains and there are holes completely through the structure. See photos in test report.

- The station needs to be completely replaced as a result of the poor condition.

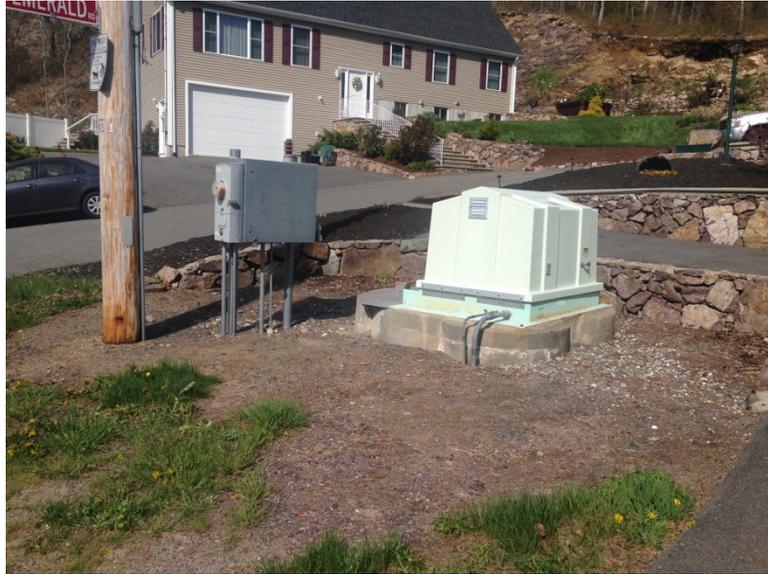
The Saugus Avenue Pump Station is a Smith & Loveless – Classic Duplex Wetwell Mounted Pump Station. The station was constructed by Schiavone Developers in 2004. The station consists of two vacuum prime pumps that are driven by 2 horsepower motors. The pumps and motors are located directly above the wetwell structure in a “dog-house” enclosure. The twelve foot diameter wetwell receives flow from two separate 8-inch gravity sewer lines.

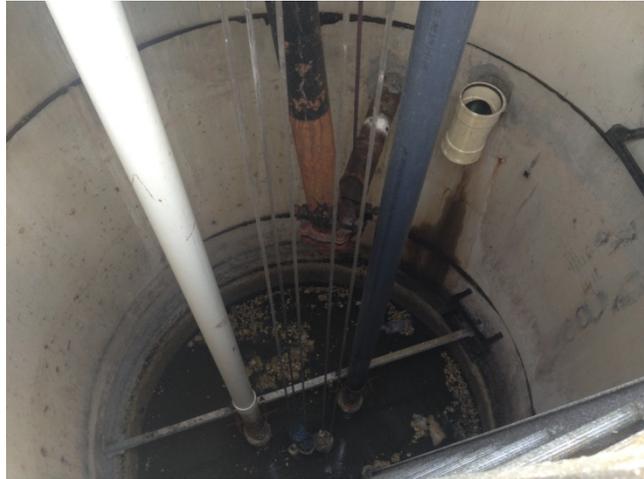
- The Town indicates that there are frequent problems with achieving the vacuum prime necessary to operate the station. The check valves often get hung up due to the lack of head pressure on the back side of the check valves.
- Suction lines for the pumps are constructed of PVC. The suction line on Pump #2 is constructed of Schedule 40 PVC, while the other suction line is constructed of Schedule 80 PVC.
- The wetwell has two influent sewer connections.
- The dresser coupling at the ductile iron forcemain connection is skewed.
- A bypass connection does not exist, but is likely not an issue due to the low flow observed at the station.
- The Town indicated that there is a significant grease issue in the collection system.

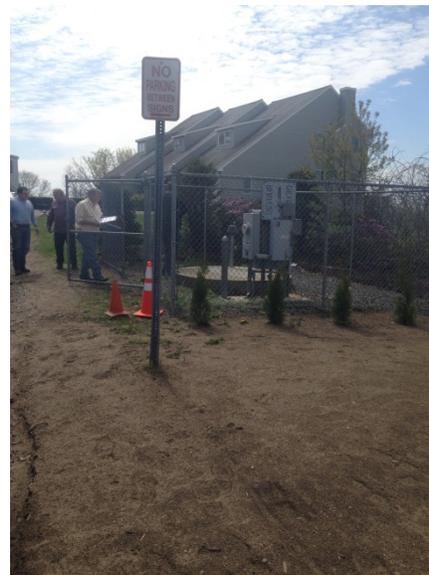
The existing wet well is constructed of pre-cast concrete manhole sections. The 'active volume' of the wet well is comprised of 6-foot (inside diameter) sections. The wet well includes a system of floats used for operation of the pumps and determining high water alarm conditions. Access to the wetwell is available through a square aluminum access hatch mounted in the pre-cast wetwell cover. Forced (pumps manually turned on) drawdown tests indicate that Pump #1 is pumping at a rate of 123.5 gallons per minute (gpm), while Pump #2 is pumping at a rate of 35.3 gpm. Pump #2 is fitted with a mix flush valve and the low output is likely related to this valve and the short duration (i.e. 30 seconds) drawdown test as a result of low liquid levels in the station at the time of the visit.

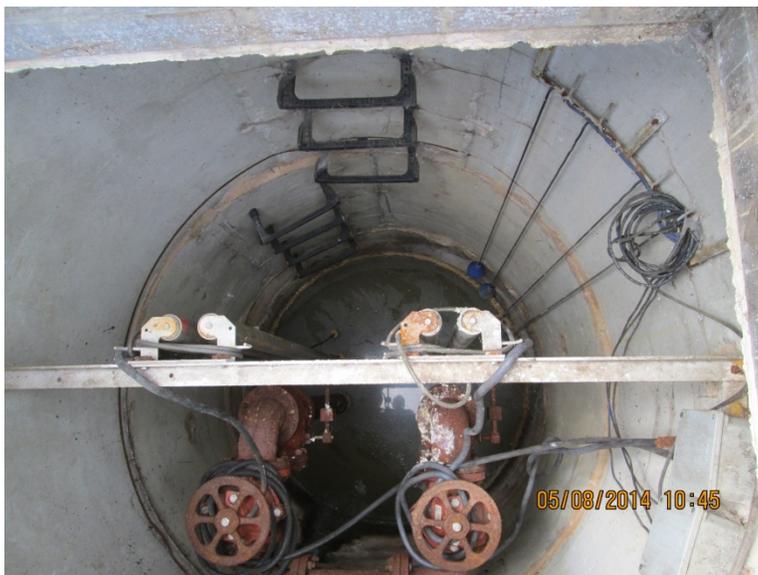
- The control panel is a 3 phase panel which has been converted to a single phase electric panel for the 1 phase service.
- The hatch is slightly misaligned, which makes pump removal difficult for the operators.
- A bypass connection does not exist.
- There is no external valve vault and all valves are located in the wetwell structure.
- There are manhole steps located inside the wetwell.

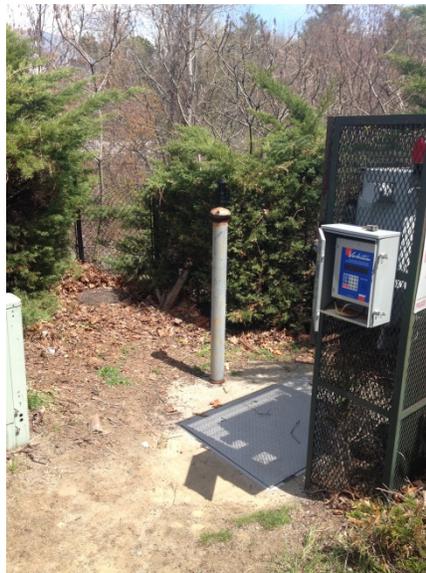
The existing wet well is constructed of pre-cast concrete manhole sections. The base of the wet well is comprised of 6-foot (inside diameter) sections. The wet well includes a system of floats used for operation of the pumps and determining high water alarm conditions. Access to the wetwell is available through a square aluminum hatch mounted in the pre-cast wetwell cover. Forced drawdown tests indicate that Pump #1 is pumping at a rate of 106 gpm, while Pump #2 is pumping at a rate of 53 gpm.

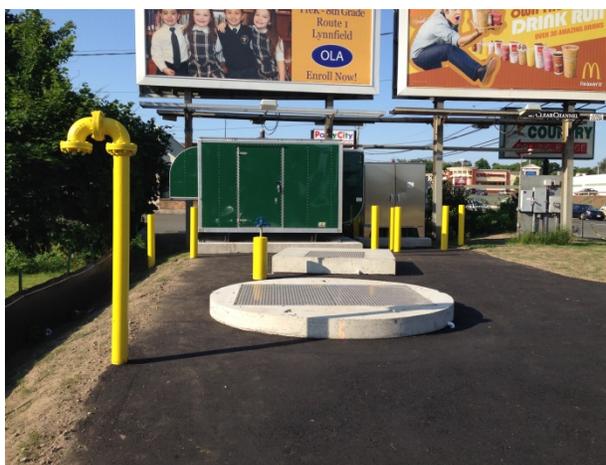
The Broadway (Route 1) PS is a newer submersible type sewer pump station. The station wetwell is 8-foot in diameter and is constructed of pre-cast concrete sections with an above grade riser section and access hatch. The discharge valving is installed in an external valve vault in order to limit the need to enter the wetwell space. The station is equipped with a dedicated standby generator to provide power to the station in the event of a service power failure. Controls for the pump station, the automatic transfer switch for the generator, the alarm auto-dialer and the electrical panels/transformer are located in an above grade outdoor weatherproof enclosure.

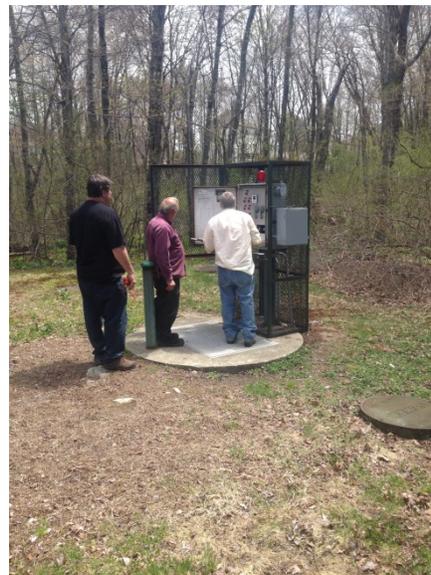
The Lamplighters Way PS is a newer submersible type sewer pump station. The station wetwell is constructed of pre-cast concrete sections with an above grade control panel. This pump station is also equipped with a large overflow tank to increase response time in the event of a station failure. At the time of our visit, the overflow tank contained raw sewage. It is recommended that the overflow tank be pumped out to provide full capacity in the event of a station failure and to eliminate potential nuisance odor conditions.

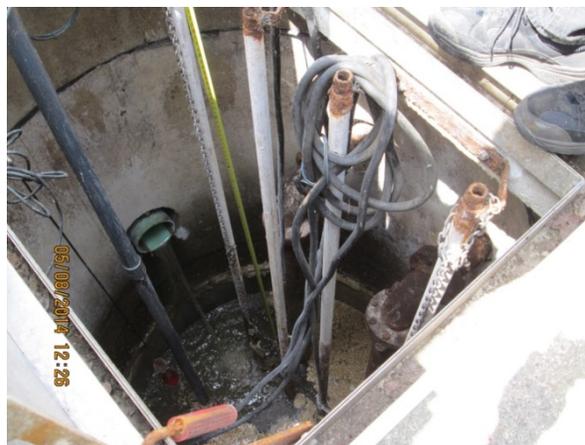
- Pump guide rails (galvanized) are

corroding.

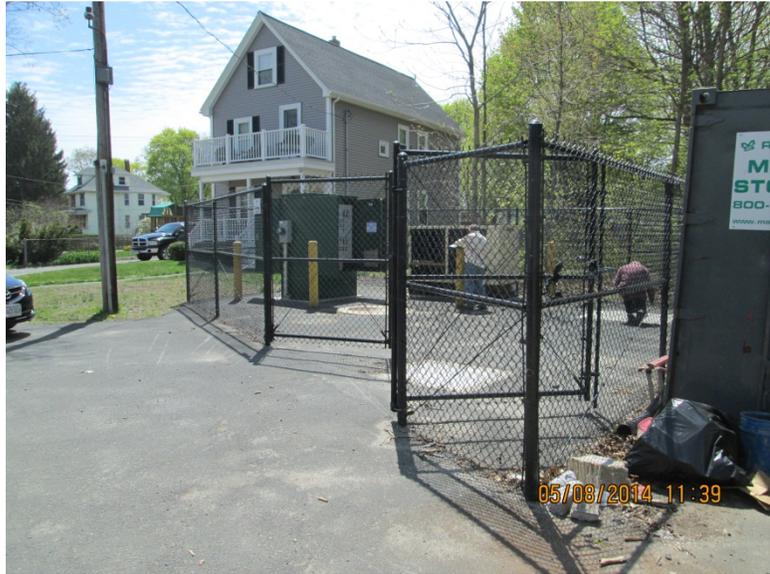
The Laurel Street PS is a newer submersible type sewer pump station utilizing duplex submersible non-clog Flygt pumps. The station wetwell is 8-foot in diameter and is constructed of pre-cast concrete sections with an above grade riser section and access hatch. The discharge valving is installed in an external valve vault in order to limit the need to enter the wetwell space. The station is equipped with a dedicated standby generator to provide power to the station in the event of a service power failure. Controls for the pump station, the automatic transfer switch for the generator, the alarm auto-dialer and the electrical panels/transformer are located in an above grade outdoor weatherproof enclosure. The pump station site is completely fenced in and paved.

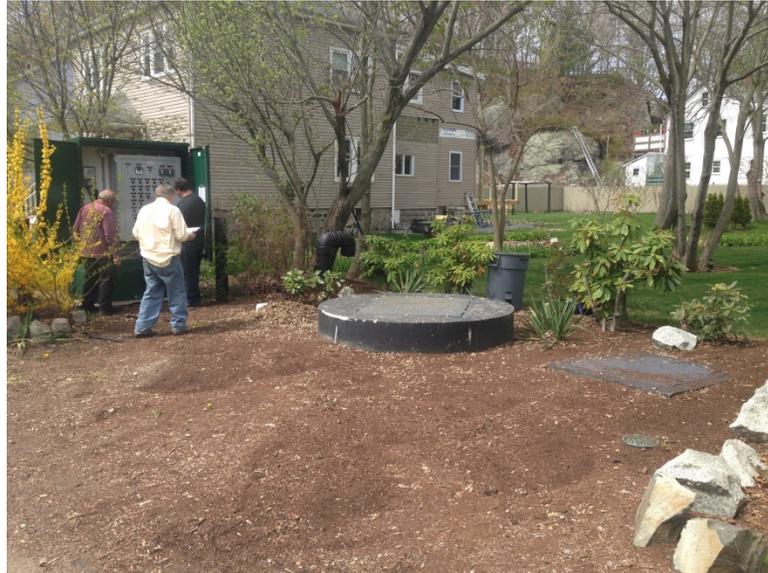
The Park Street PS is a submersible type sewer pump station utilizing duplex submersible non-clog Flygt pumps. The station wetwell is 6-foot in diameter and is constructed of pre-cast concrete sections with an above grade riser section and access hatch. The discharge valving is installed in an external valve vault in order to limit the need to enter the wetwell space. Controls for the pump station, manual transfer switch, the alarm auto-dialer and the electrical panels/transformer are located in an above grade outdoor weatherproof enclosure. A portable generator receptacle is located on the outside of the weatherproof enclosure.

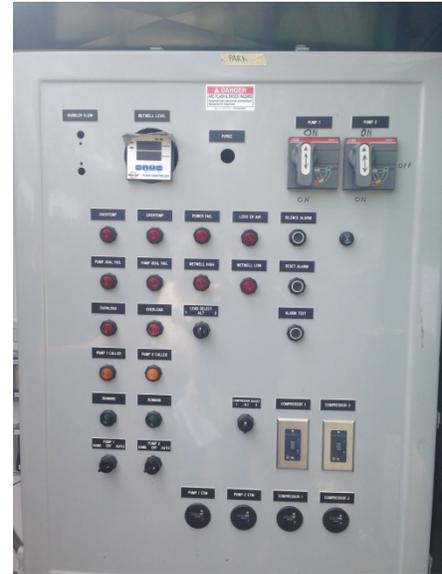
The pump station does not have a dedicated generator set for stand-by power. The electrical service cabinet is equipped with a receptacle for connection of a portable generator for use during extended power outages. The town has a portable generator that can be used at the site.

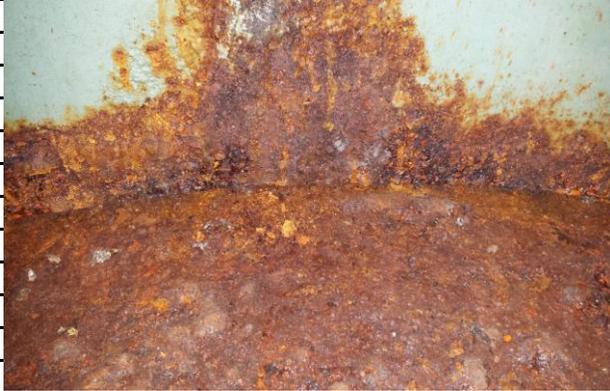
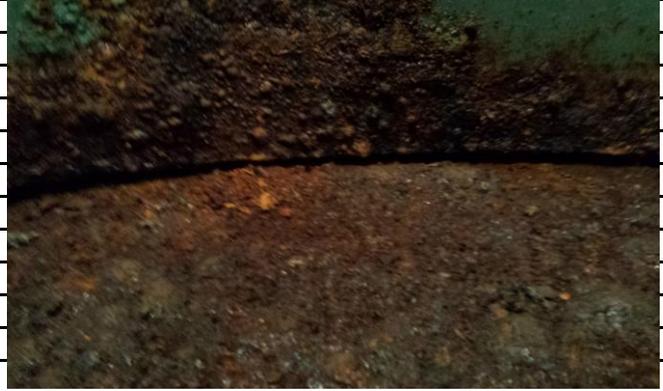
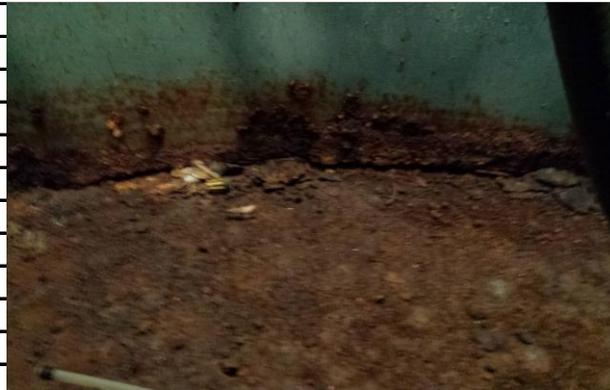
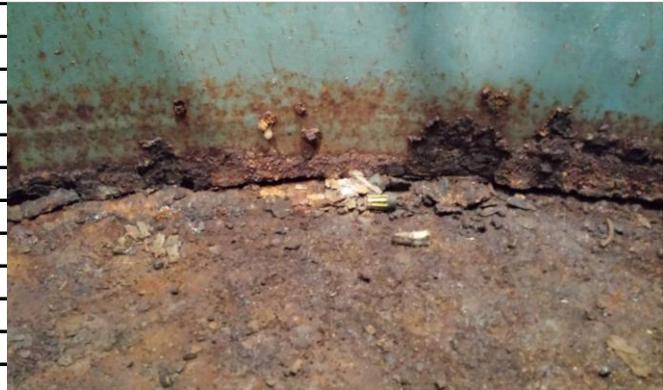
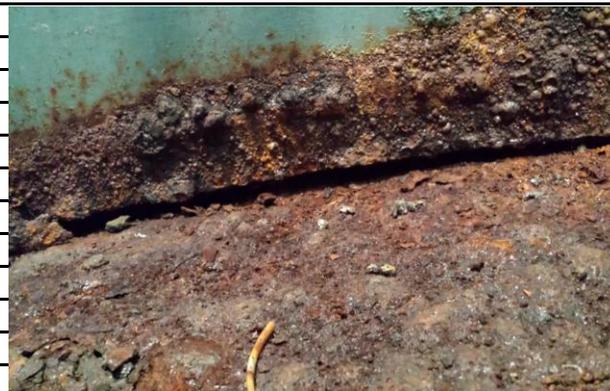
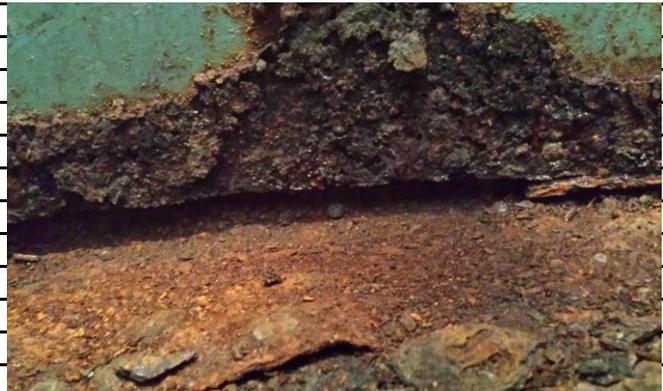
All Pictures above are on Floor of Morris Pump House

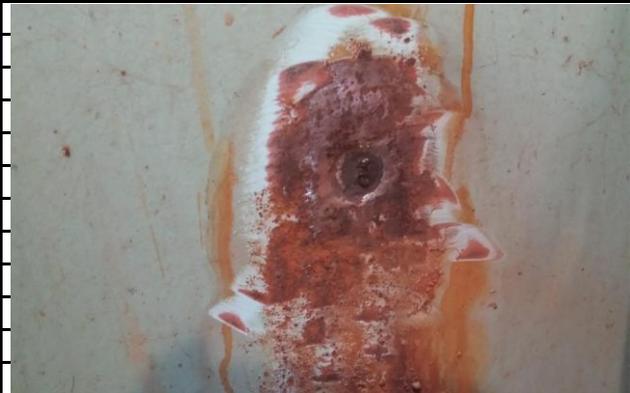
Morris Side Wall in Pump House

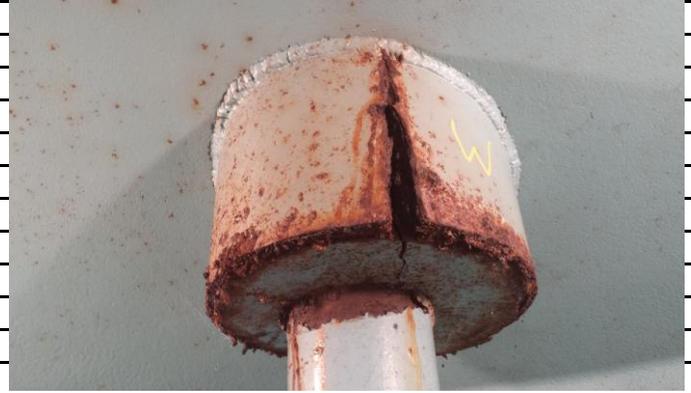
Top of Morris Pump House Inside

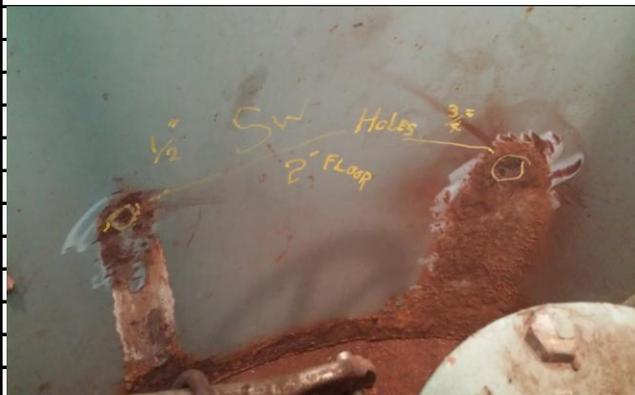
Southwest of Morris Pump Wall

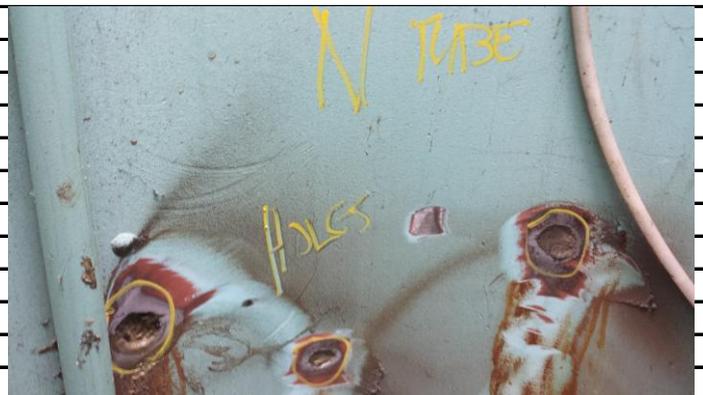
North Side Of Morris Pump Tube Walls

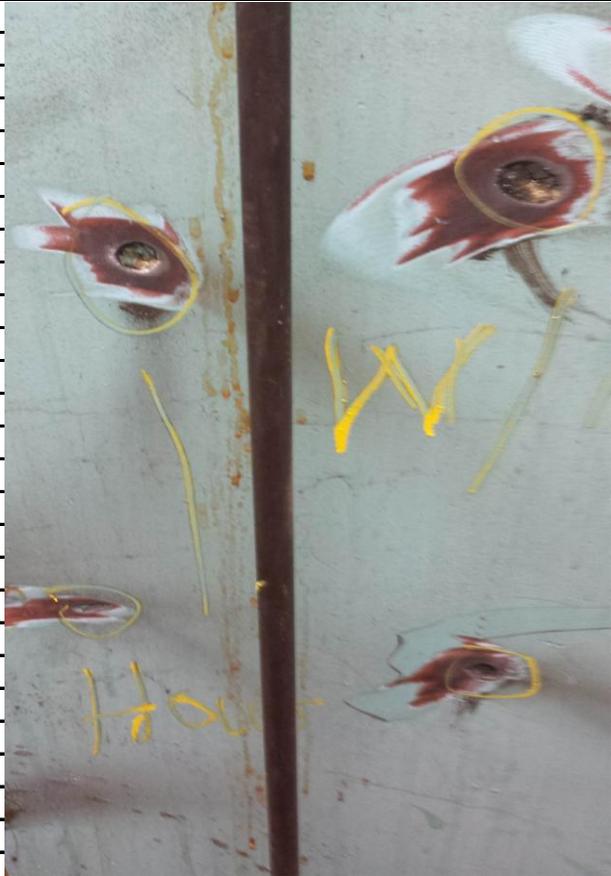
West Side Tube Wall
