## Saugus Walk Assessment Saugus, MA

September 12, 2018

## **Walk Assessment Overview**

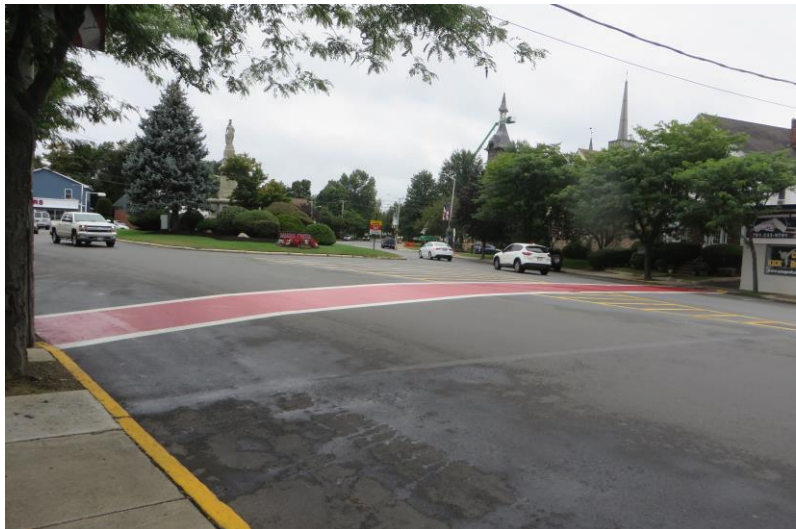
Central Street and Main Street/Hamilton Street come together at a large rotary in Saugus Center, right next to Town Hall. The vehicular travel lanes are very wide at this location, resulting in fast-moving traffic and long pedestrian crossing distances that can create safety hazards for people walking. Several triangular yellow painted areas around the crosswalks help guide vehicular movements through the rotary and create pedestrian refuge islands of sorts, but these areas can be further enhanced to provide additional safety benefits. **Strategies to improve walking safety include the following:**

*Excessively long crossing distances and wide vehicular travel lanes present challenges for people walking in Saugus Center.*

- **Use fog lines and bike lanes to narrow vehicular travel lanes and calm traffic.** These pavement markings should be implemented on the approaches to the rotary and through the rotary itself to reduce the vast roadway expanse dedicated to motor vehicles and create a safer pedestrian environment.

- **Use curb extensions/bumpouts to reduce crossing distances, calm traffic and increase pedestrian visibility.** Bumpouts can be added at low cost in the near term using paint, planters and/or plastic flex posts.

- **Enhance the current triangular yellow painted areas around the crosswalks with planters, plastic flex posts and/or green space.** This will create physically protected refuge islands for pedestrians in the middle of the crosswalks, while also helping to further calm traffic. Some walk assessment participants suggested that these areas could even be turned into small parks that add green space to the public realm in Saugus.

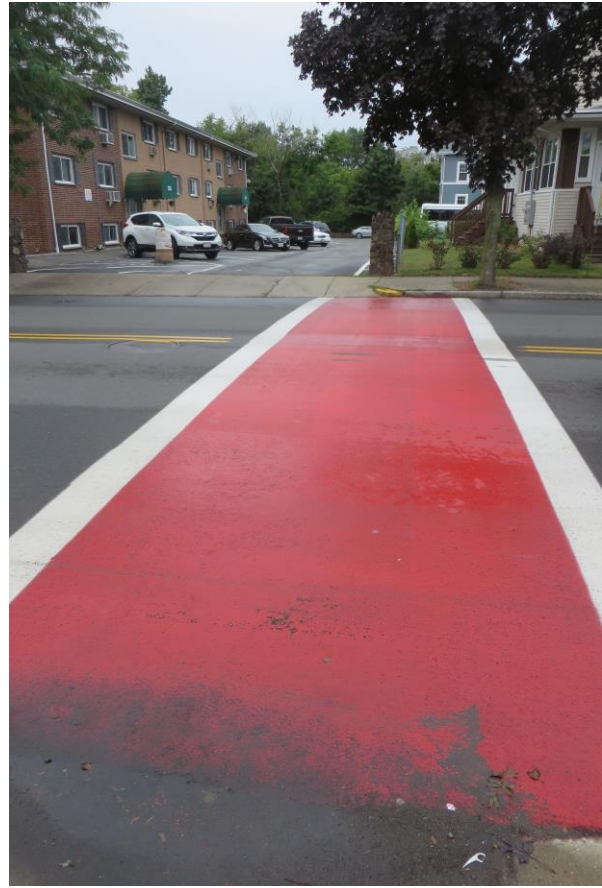
South of the rotary outside Town Hall, Central Street has narrower travel lanes, several small businesses, and parking on both sides of the street that creates buffers between people walking and motor vehicles. All of these attributes contribute to a more hospitable environment for pedestrians, but several challenges remain. As described earlier in this report, the conditions of sidewalks and crosswalks are sometimes poor, with some crosswalks lacking curb ramps or ending in driveways. In addition cars often park immediately next to crosswalks, blocking sightlines between people walking and people driving. Walk assessment participants also noted that several street trees had been removed along Central Street, leaving behind unsightly and uneven tree pits that present tripping hazards. **Strategies to improve walking safety include the following:**

*Several crosswalks along Central Street end in driveways and lack ADA compliance.*

- **Improve conditions and locations of sidewalks, crosswalks and curb ramps for visibility, accessibility and ADA compliance.** As mentioned earlier in this report, crosswalks should be enhanced with high-visibility pedestrian signage, including in-street pedestrian delineators at unsignalized or midblock locations. Crosswalks that end in driveways should be relocated and ADA-compliant curb ramps with tactile warning panels should be provided at all crosswalks. Some walk audit participants also suggested that sidewalks could be widened to provide an expanded pedestrian realm.

- **Create even tree pits that do not present tripping hazards.** Regardless of whether street trees are re-planted or not, improving the tree pits will create a safer and more visually appealing pedestrian environment. Empty tree pits can be filled with mulch or permeable pavers to create continuous walking surfaces that can also accommodate future tree growth.

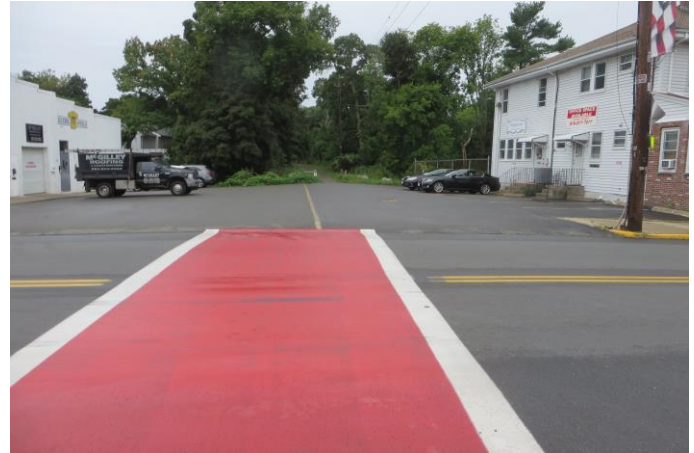
Walk audit participants observed that motor vehicles often fail to slow down on the approach to the Northern Strand trail crossing on Central Street. The parking lot on the west side of the street at this location also presents challenges, as there is no path delineating walking and biking access across the parking lot to and from the trail. **Strategies to improve walking safety include the following:**

*The parking lot at the Central Street trail crossing lacks a clearly defined path for pedestrians and cyclists.*

- **Paint a clearly marked and high-visibility path across the parking lot to the trail to indicate the presence of people walking and biking.**
- **Consider installing a flashing light or a pedestrian/cyclist-actuated Rectangular Rapid Flash Beacon (RRFB) as a traffic calming measure at the trail crossing.**
- **Install appropriate fencing at the trail entrances to slow pedestrians and cyclists as they approach the road crossing and make them aware of oncoming traffic.**

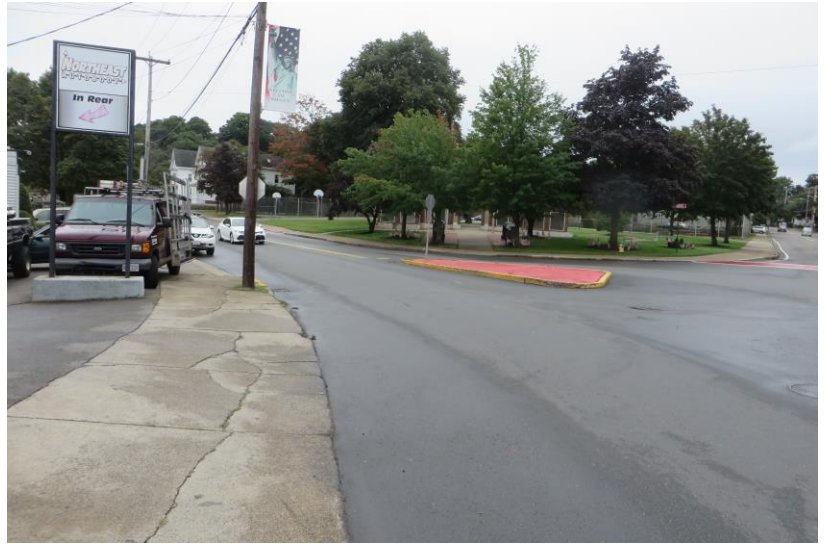
The intersection of Central Street and Winter Street just south of the trail crossing is another overly wide expanse of pavement that induces traffic to move at high speeds, especially northbound traffic coming down the hill on Central Street. Due to the presence of an auto body shop with an extended curb cut, the crosswalk across Winter Street is set far back from the intersection and away from the pedestrian desire line.

*Wide travel lanes and wide turning radii present challenges for people walking at the intersection of Central Street and Winter Street.*

- **Add fog lines along Central Street and Winter Street to narrow the vehicular travel lanes and slow traffic down.**
- **Use curb extensions/bumpouts to reduce crossing distances, calm traffic and narrow wide turning radii for motor vehicles.** Bumpouts can be added at low cost in the near term using paint, planters and/or plastic flex posts.
- **Explore ways to potentially relocate the crosswalk across Winter Street closer to the intersection.** This may require reconfiguring the existing curb cuts at the auto body shop to better accommodate pedestrians. A relocated crosswalk can also utilize the concrete median island that currently exists at this intersection as part of a pedestrian refuge.

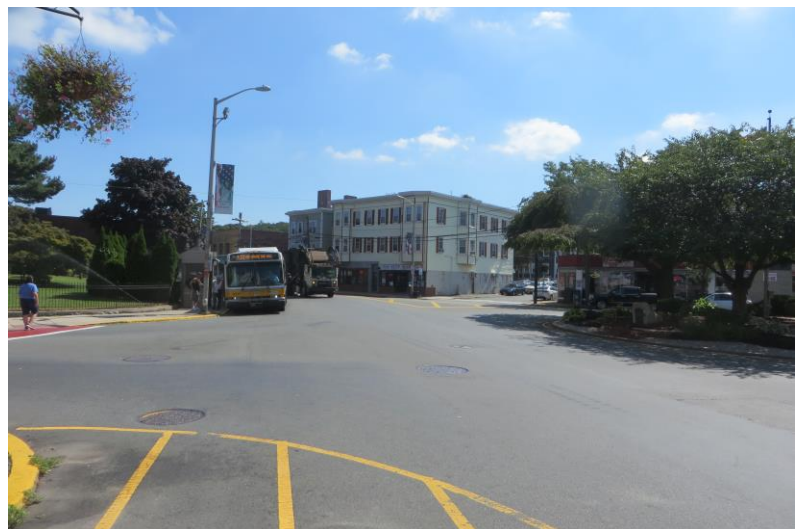
*Wide expanses of pavement and sidewalk crowding at bus stops detract from the pedestrian environment in Cliftdale Square.*

square/rotary itself is a very wide expanse of pavement that enables high traffic speeds. The conditions of sidewalks and crosswalks are also sometimes poor, with some narrow sidewalks creating pedestrian choke points and some crosswalks lacking curb ramps or ending in driveways.

- **Use fog lines and pavement markings to narrow vehicular travel lanes through the rotary and calm traffic.**
- **Use curb extensions/bumpouts to reduce crossing distances, calm traffic and increase pedestrian visibility.** Bumpouts can be added at low cost in the near term using paint, planters and/or plastic flex posts. A yellow painted bumpout already exists at the corner of Jackson Street, presenting a potentially replicable model.

- **Improve conditions and locations of sidewalks, crosswalks and curb ramps for visibility, accessibility and ADA compliance.** As mentioned earlier in this report, crosswalks should be enhanced with high-visibility pedestrian signage, including in-street pedestrian delineators at unsignalized or midblock locations. Crosswalks that end in driveways should be relocated and ADA-compliant curb ramps with tactile warning panels should be provided at all crosswalks.

- **Consider widening sidewalks to provide an expanded pedestrian realm.** This is especially important in front of the bus shelter at the corner of Jackson Street, which currently is a pedestrian choke point due to the narrow sidewalk there.

- **Enhance the current triangular yellow painted areas with planters, plastic flex posts and/or green space.** This will help to further regulate motor vehicle movements through the rotary and thus calm traffic.

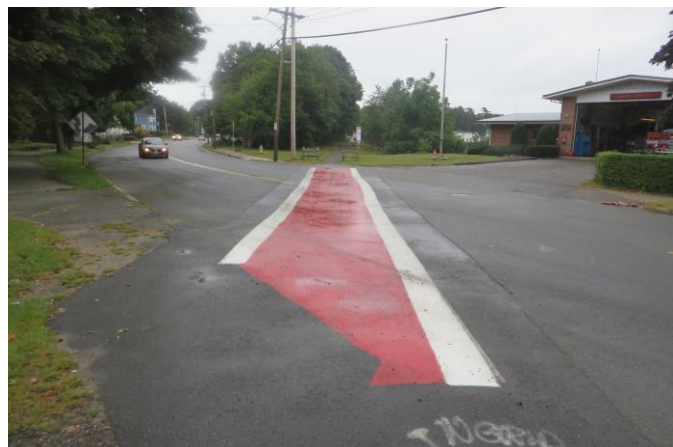
Walk assessment participants observed that motor vehicles often fail to slow down on the approach to the Northern Strand trail crossing at Essex Street and School Street. The current trail crossing is a diagonal across Essex Street. While this is the most direct desire line for cyclists and pedestrians using the trail, it also leaves them more exposed to motor vehicles on Essex Street.

The presence of a fire station at this location presents additional challenges. Walk assessment participants noted that people driving often park immediately outside the fire

*Shifting the crosswalk to the other side of the fire station will reduce pedestrians' and cyclists' exposure to oncoming traffic at the School Street trail crossing.*

station to use the nearby athletic fields. This creates obstacles for cyclists and pedestrians using the trail, in addition to interfering with the operations of the fire department itself. **Strategies to improve walking safety include the following:**

- **Consider reconfiguring the trail crossing to be perpendicular across Essex Street.** This would shift the crossing to the other side of the fire station, thus reducing pedestrians' and cyclists' exposure to oncoming traffic on Essex Street. If this shift is implemented, it should be accompanied by the installation of ADA-compliant curb ramps, as well as the painting of a clearly marked and high-visibility path across the fire station's curb cut to indicate the presence of people walking and biking.

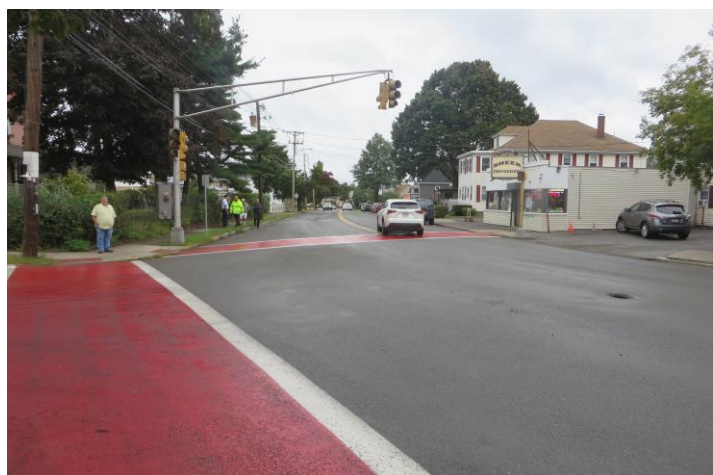
The intersection of Essex Street and Felton Street, which is crossed by many children attending local schools, presents several challenges for pedestrians. Traffic moves at high speeds along Essex Street without slowing down, despite the presence of a flashing yellow light that changes to solid red when the pedestrian button is pushed. A guard rail was installed on the southwest corner of the intersection after fast-moving cars crashed into the house there several times. While standing at the intersection, walk audit participants happened to meet a longtime resident of the house, who

*Crossing safety is a challenge at the intersection of Essex Street and Felton Street.*

In addition to the issues with speed, drivers often double park outside the convenience store at this intersection, even though parking is not allowed there. These illegally parked cars present additional obstacles and safety hazards for pedestrians. **Strategies to improve walking safety include the following:**

- **Add fog lines along Essex Street to narrow the vehicular travel lanes and slow traffic down.**
- **Add curb extensions/bumpouts, an in-street pedestrian delineator, and a pedestrian refuge island at the intersection.** All these measures can be implemented at low cost in the near term and will help calm traffic and improve crossing safety. Bumpouts and pedestrian refuge islands can be added using paint, planters and/or plastic flex posts.

- **Restrict parking on Essex Street outside the convenience store to improve pedestrian visibility.** The installation of “No Parking” signs may be accompanied by increased police enforcement, yellow paint on curbs, and physical measures on the street to block parking, such as paint, planters and/or plastic flex posts.

- **Consider replacing the flashing yellow light with another traffic control device proven to be more effective at slowing traffic at locations like this one.** Devices may include a full traffic signal, a pedestrian beacon, or a STOP sign. This will require further study as to whether the intersection meets certain engineering criteria to warrant such a move.
