Town of Saugus, Massachusetts

ILLICIT DISCHARGE DETECTION & ELIMINATION (IDDE) PLAN

June 2019

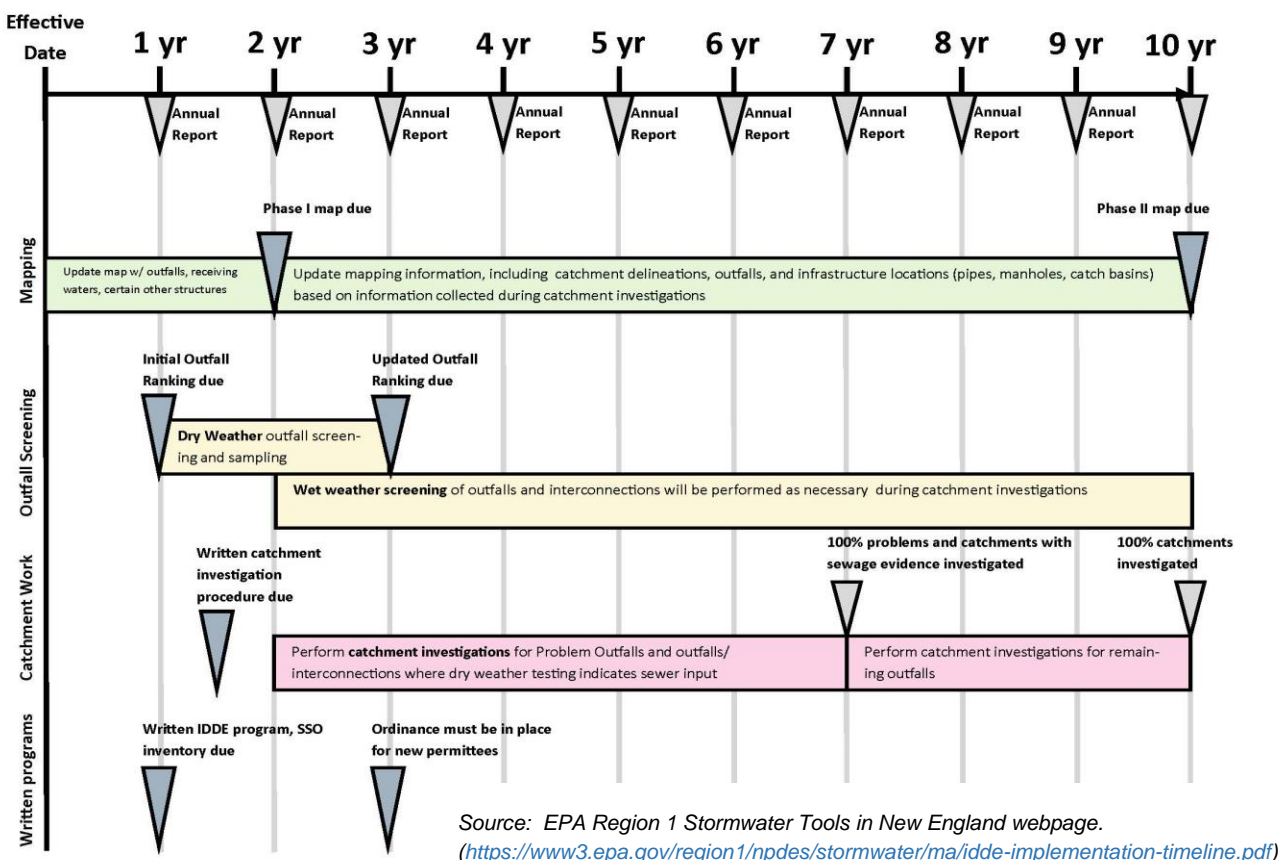
Figure 2. IDDE Program Implementation Timeline

It is the Town's intent to adhere to the IDDE timeline requirements of the MS4 permit as graphically shown in **Figure 2**, as provided by the EPA. **Table 1** presents a summary of the IDDE program requirement deadlines for the current permit term.

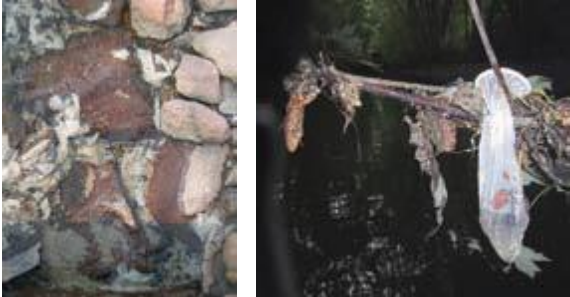
<p>Toilet paper or other sanitary items directly around the storm drain outlet are indicators of an upstream illicit connection.</p>

In the event an outfall is inspected, and no flows are observed, indicators of illicit flow evidence may be used in the determination of likely illicit discharges. Some observable evidence of an illicit discharge includes the presence of toilet paper and other sanitary items, staining, grease deposits, or excessive vegetation or bacterial growth. Examples of illicit flow evidence in non-flowing outfalls are shown in **Figure 5**. These examples are excerpts from the Illicit Discharge Detection and Elimination: A Guidance Manual for Program Development and Technical Assessments by the Center for Watershed Protection and Robert Pitt, 2004.

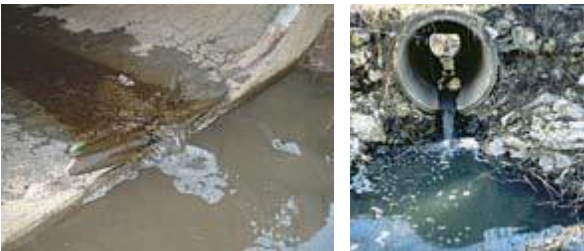
<p>Suds present at an outfall may indicate an illicit connection and likely when accompanied by the presence of a fragrant detergent odor.</p>

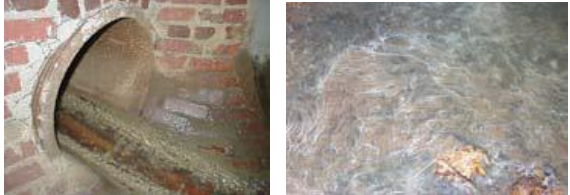
<p>Bacterial growth at an outfall indicates nutrient enrichment likely from sanitary connections / defects.</p>

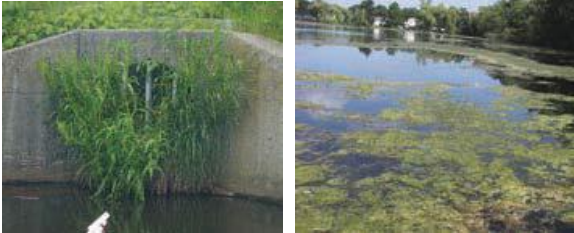
<p>Excessive vegetation and algae growth may indicate enriched flows associated with sewage or fertilizers from lawn care</p>

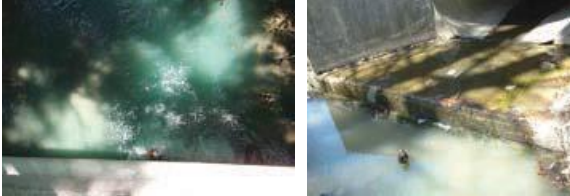
<p>Water color indicators may identify the presence of an illicit connection or illegal dumping and may require additional investigation.</p> <p>Note: water color may also be a result of minerals and algae growth</p>

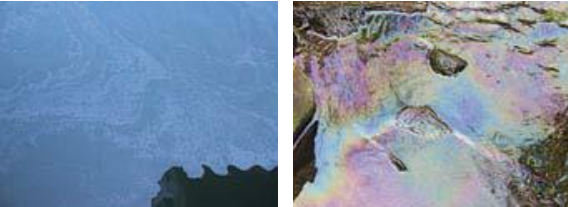
<p>Oily Sheen or Film may indicate the presence of an illicit connection or illegal dumping of pollutants.</p> <p>Note: some oils are organic and should be differentiated from Synthetic oils before using as an indicator</p>
